Long-Term Infiltration Performance Evaluation of Dutch Permeable Pavements Using the Full-Scale Infiltration Method

Permeable Pavements and Their Role in Sustainable Urban Development

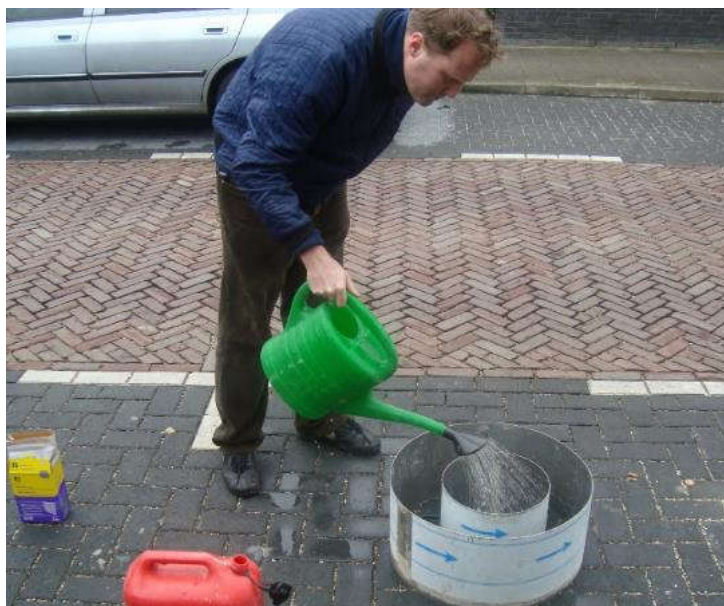
Ring infiltrometer tests [7] were originally developed to determine the hydraulic conductivity of in-situ field soils for evaluation of their irrigation properties. Double-ring infiltrometer testing (Figure 4) is generally now the preferred and more accurate method for measuring permeable pavement infiltration rates, as the outer ring helps reduce errors caused by potential lateral flow through the media under the pavement. However, single-ring infiltrometers are often used when the hydraulic conductivity of the media is high, as it can be difficult to keep water supplied to two rings in these conditions. The rings are usually sealed to the pavement using plumber’s putty or other sealants using ring infiltration tests. A number of previous studies have used some type of ring infiltrometer tests to estimate the infiltration capacity of permeable pavements [2,5,6].

Figure 4. Double-ring infiltrometer tests.

Water is generally supplied to the rings using either a constant head or a falling head method. Constant head means that the water level inside the rings is kept at a constant, predetermined level for the duration of the testing. This is done by supplying water to the rings at the same rate that the water is infiltrating into the pavement. The flowrate of the water is then divided by the cross-sectional area of the ring to calculate the infiltration rate (usually reported in mm/h).

In the falling head method, a relatively large volume of water is supplied to the rings at one time and the time taken for the water to fall between two predetermined points inside the rings is measured. The average flowrate is calculated by dividing the total volume of water contained between the two points within the ring by the time taken for the water to fall. The infiltration rate is then calculated in a similar way to the constant head method. Owing to the difficulty of supplying water at a constant flowrate in the field, the falling head method is more commonly used to estimate the infiltration rate through permeable pavement surfaces.

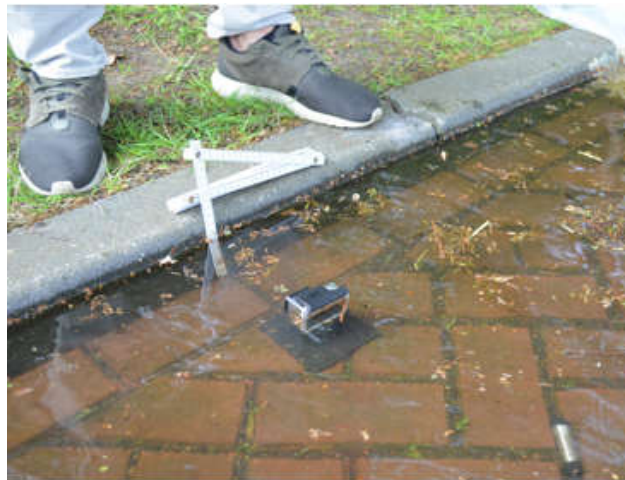
Four different measurement methods were used to determine the infiltration rates with the FSIT method. These were self-logging pressure transducers (minidiver), hand held ruler measurements (to verify the measurements of the pressure transducers), calibrated underwater cameras (Figure 6), and time-lapse photography. Video and photographs of the test and each hand measurement were taken for documentation and verification purposes.

Figure 6. Minidiver installed; hand measurement point; underwater camera set-up.

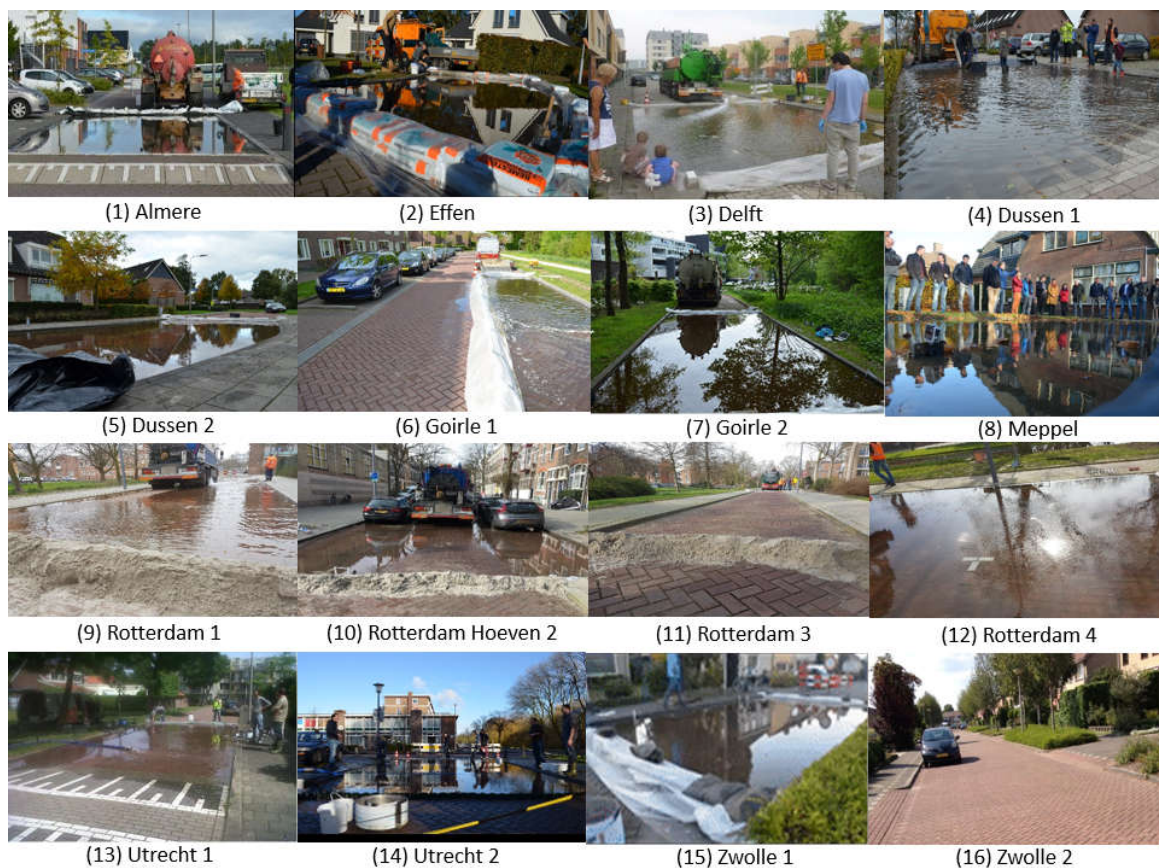
All 16 test pavements were sealed, inundated, and monitored (Figure 7) as described above. At one of the test locations (Goirle 2), the pavement was tested three times to see how pre-saturation affected infiltration rates. There was a break of approximately 15 min between the three tests.

Figure 7. All 16 pavements tested using FSIT and the location numbers in Figure 3.

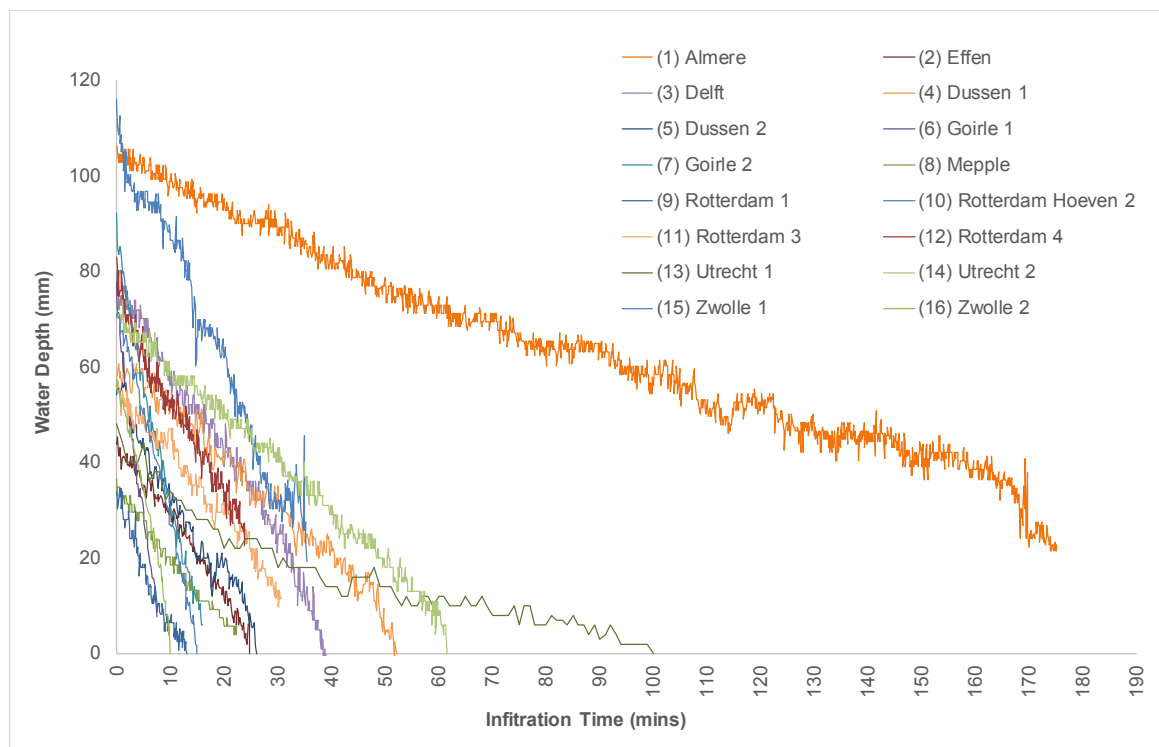
The 16 pavements were tested using the methodology described above. The pressure transducer readings were then plotted against time to generate precise infiltration curves for each of the test sites (Figure 8).

Simple linear regression analysis was used to generate lines of best fit for the transducer readings from each site. The equations of the linear regression lines were then used to calculate the average infiltration rate in mm/h for each test site (Table 2). Some of these lines were extrapolated past the x-axis to achieve the required 60 min duration which explains the negative depth values in Table 2.

Figure 8. Infiltration curves for each of the 16 test sites with location numbers in Figure 3b.

Variations in ground water levels may have affected the infiltration capacity of the permeable pavements. The water table was higher at some pavement test locations (particularly in the western areas of the Netherlands), while the permeability of soils in the eastern test locations were generally higher. In areas of high table water, the permeable pavements soil subgrade may have a much higher moisture content than low water table soils. This may restrict the infiltration of runoff water into the pavement structure, thereby reducing surface infiltration rates. This may explain the slower infiltration rates of some of the test pavements in the low-lying areas of the Netherlands (Figure 8).

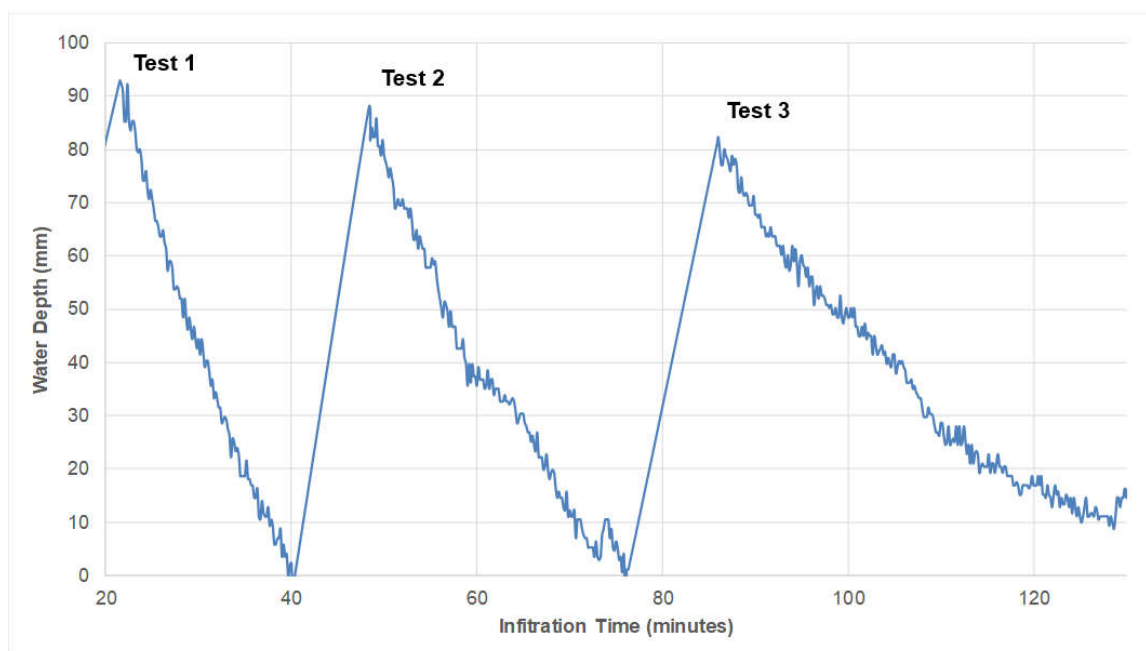
Figure 9 shows the results of the Goirle 2 infiltration tests where the pavement was inundated three times to assess how pre-saturation affected infiltration rates.

The equations of the linear regression lines for the three Goirle 2 tests were used to calculate the average infiltration rate in mm/h for each test site and these are shown in Table 3.

Figure 9. Results of FSIT testing at Goirle 2.

Figure 9 clearly shows that the infiltration rate of the permeable pavement installation at Goirle 2 was affected by pre-wetting. Three FSIT tests were performed on this pavement, one after the other. The time taken for the water to fully infiltrate into the pavement surface increased from approximately 18 min for the first test, to approximately 25 min for the second test, and to approximately 45 min for the final test. This resulted in a 39% reduction in infiltration capacity for the saturated pavement (Test 2) compared to the unsaturated pavement (Test 1). The second saturated test (Test 3) showed a 65% reduction in pavement infiltration between Test 2 and Test 3. These results suggest that the pavement may have been approaching its maximum infiltration rate. However, it was not possible to accurately assess the moisture content of the pavement subgrade, so it is difficult to ascertain whether the pavement may have been able to accommodate further testing. Further infiltration tests may have demonstrated a saturation point for the pavement where it could no longer infiltrate any more water. Unfortunately, further tests were not conducted at that time. However, this will be investigated in future research.

The results in Figure 9 clearly show that initial (unsaturated) infiltration rate observed at the Goirle 2 site would conform to the new guidelines [13]. However, infiltration rates observed during subsequent (saturated) tests show that these rates (178 and 62 mm/h, respectively) would not meet the guidelines. This is an important finding that again suggests that if unsaturated infiltration capacity test results are used as design input, the infiltration capacity may be significantly overestimated. The results of this study therefore suggest that a minimum of three different FSIT tests are undertaken at the same pavement location, and that the results should be averaged, to ensure appropriate infiltration rates are observed, recorded, and used in design.
